2 DOUGLAS AVE, SOUTH PERTH

RE-ROOF

2 Douglas Ave
South Perth, WA

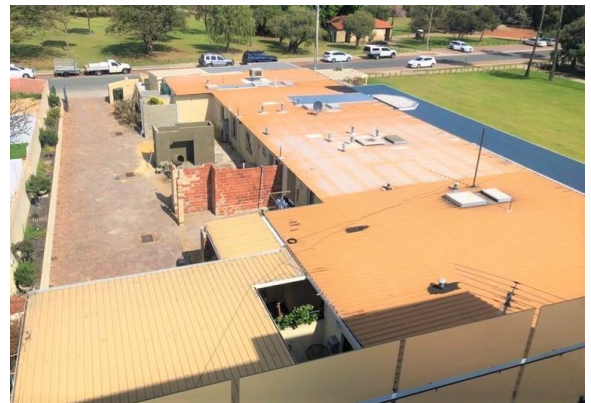
Image 1: Overhead view prior to works

The existing roof of the structure was displaying evidence of extensive leaking, causing widespread water damage to the internal areas of the apartment units. The Council of Owners approached BUSS Roof Plumbing to provide a quote to replace the defective roof with a new Colorbond roof.

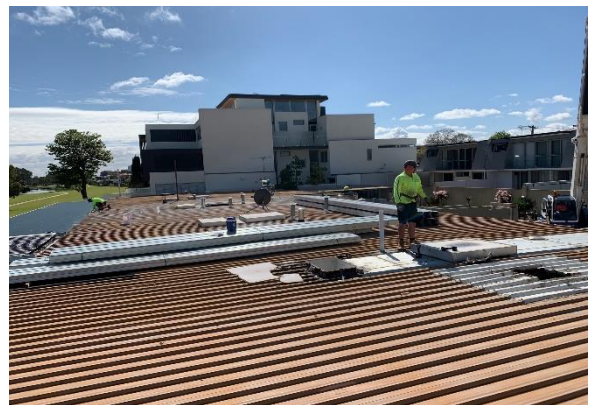
Image 2: Roof works midway

The existing roof, which was slightly curved, prevented the penetrations from being dry pan flashed and therefore allowing water to penetrate. To solve this issue BUSS' roof plumbers worked with a builder on site to construct and design 2 new roof battens at the high point of the roof line. This allowed for the installation of dry pan flashings to all the roof penetrations, ensuring total water tightness.

The existing skylights were raised above the roof line, thus permitting water ingress due to silicone breakdown. BUSS Roof Plumbing removed the external skylights and replaced them with Ampelite Gel Coat Wonderglass (fibreglass) sheeting. This was designed to match the new roof sheet profile providing water tightness as well as 99% UV block out. As well as making it aesthetically pleasing to the eye as there are now no external penetrations visible.

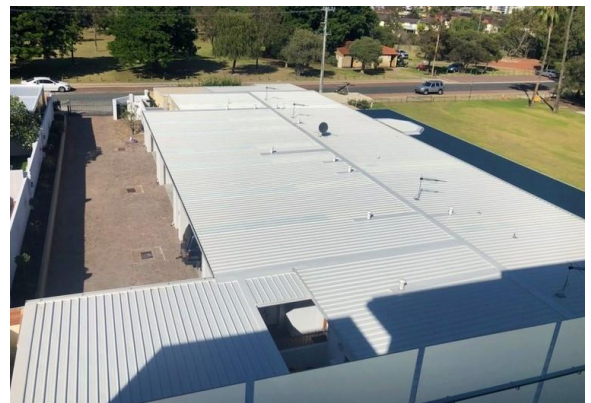
Image 3: Works at completion
